Remediated sites and brownfields Success stories in Europe

*A report of the European
Information and
Observation Network's
National Reference Centres
for Soil (Eionet NRC Soil)*

2015

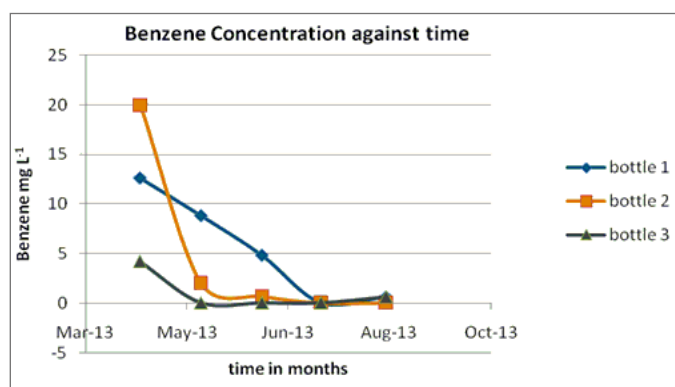
Benzene concentrations during a period of three months

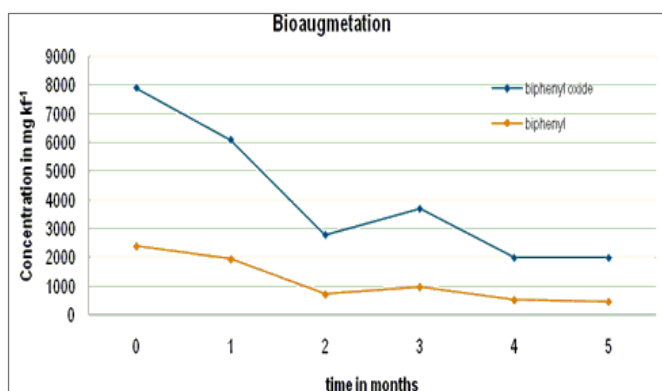
Development of degradation, second tray (biodegradation)

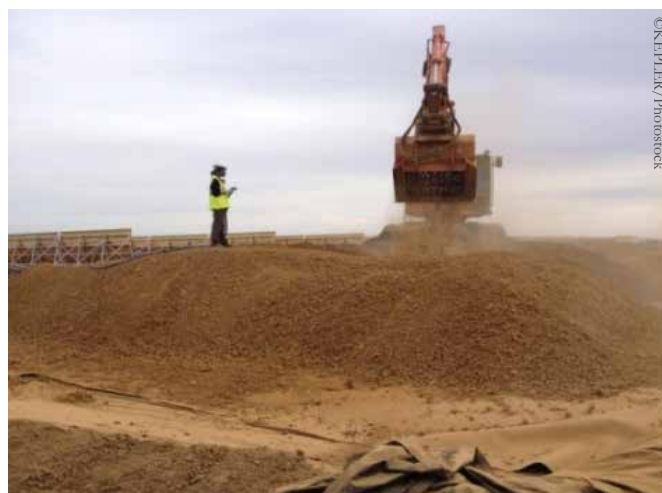
Soil turning and applying of the solution of nutrients and microorganisms.

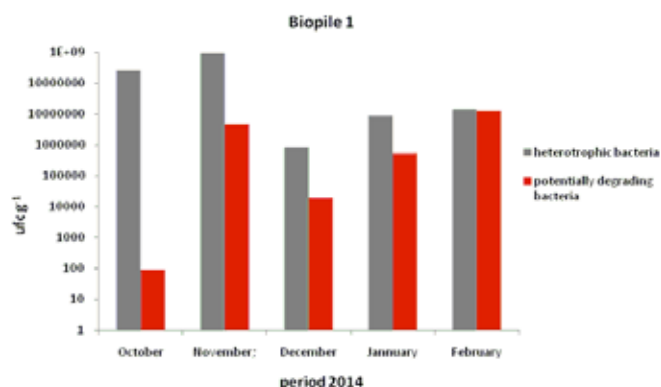
Concentrations of bacteria in biopile 1 over a period of 5 months (ufc g-1).

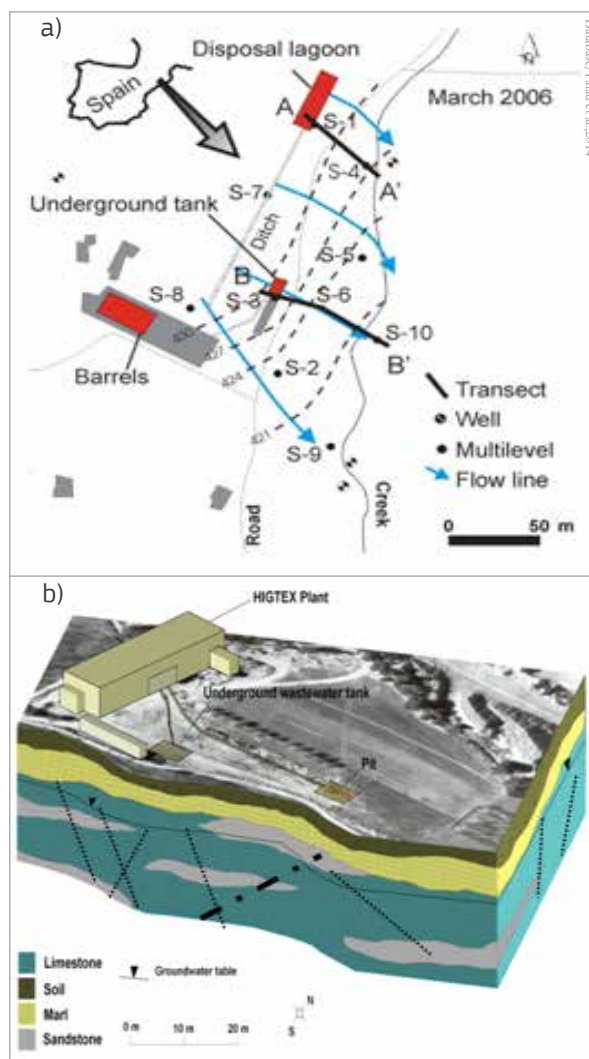
a) location of transects A and B Modified from Palau et al., 2014¹ and b) Geology, source locations, groundwater monitoring system

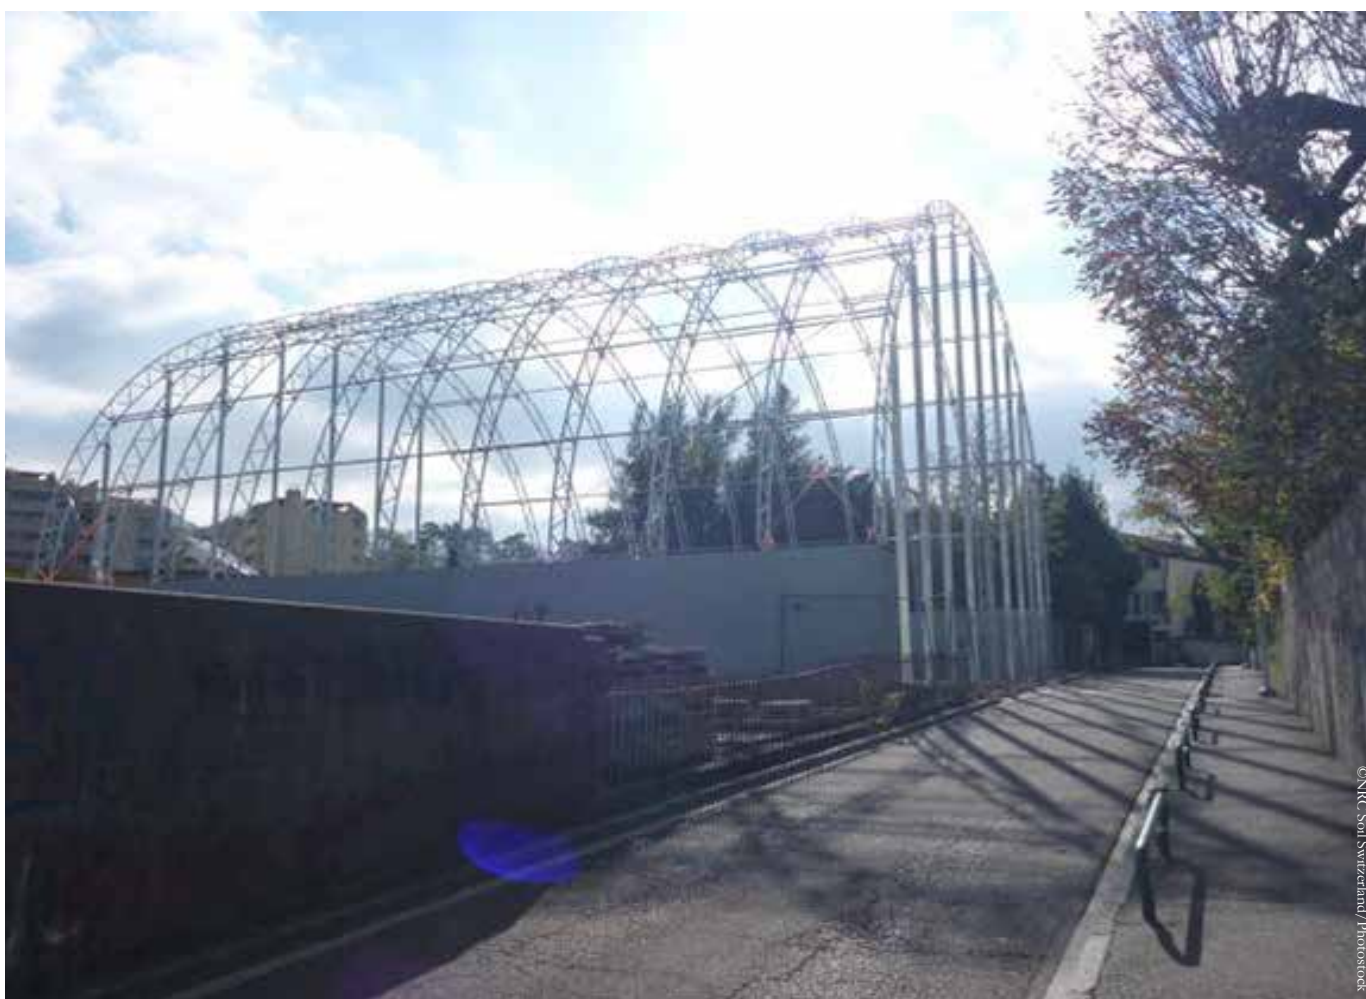
Protective cover under construction

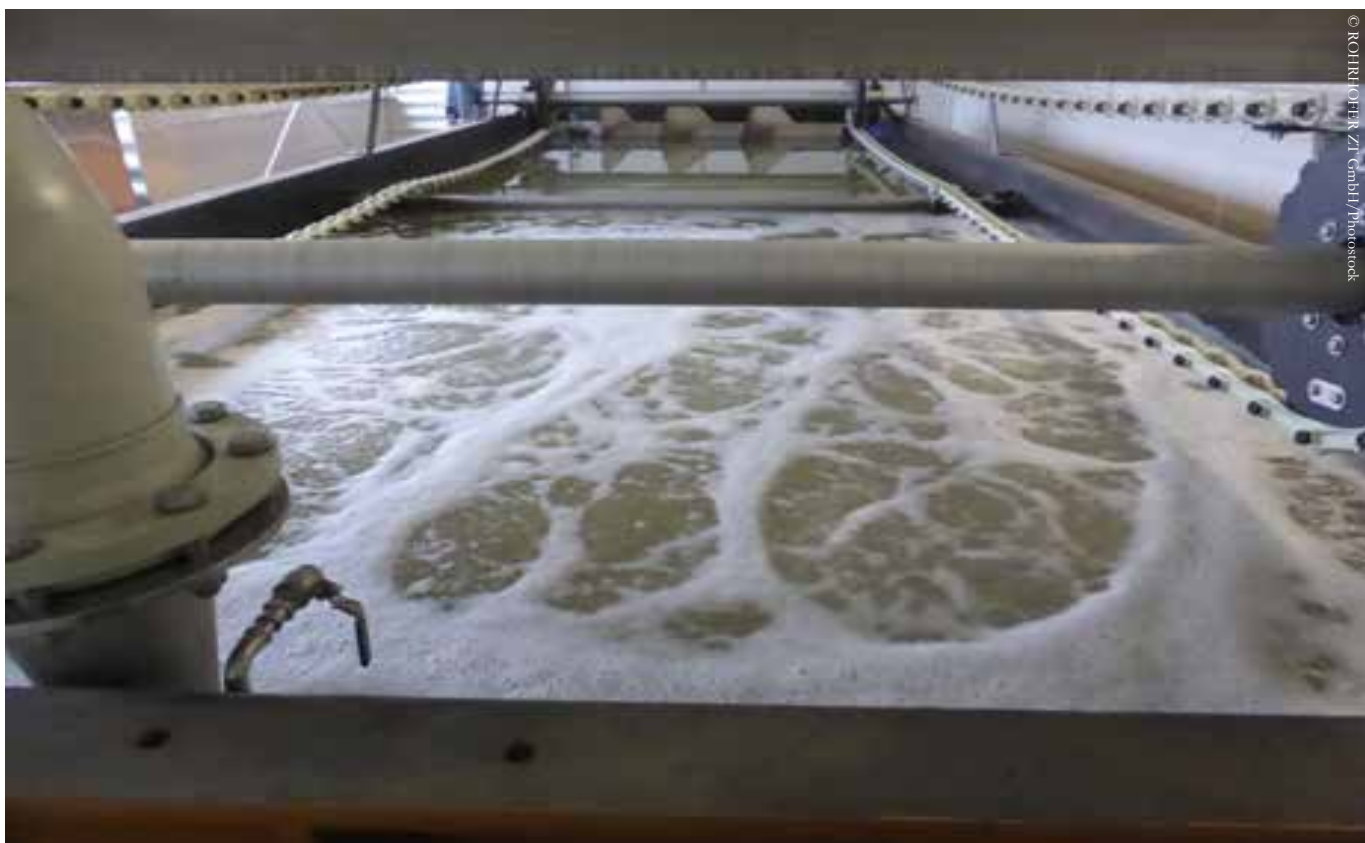
Pre-aeration and sedimentation tanks

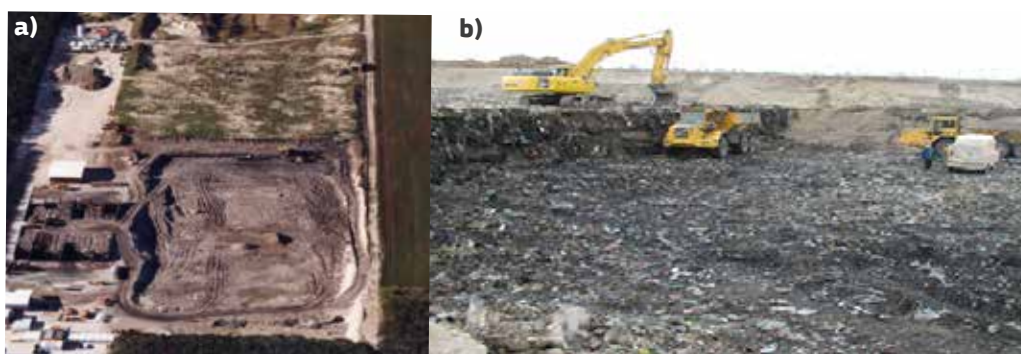
From left to right: a) Aerial view of the site at the beginning of the clear-up operations
b) Excavation of municipal waste with a skeleton-excavator

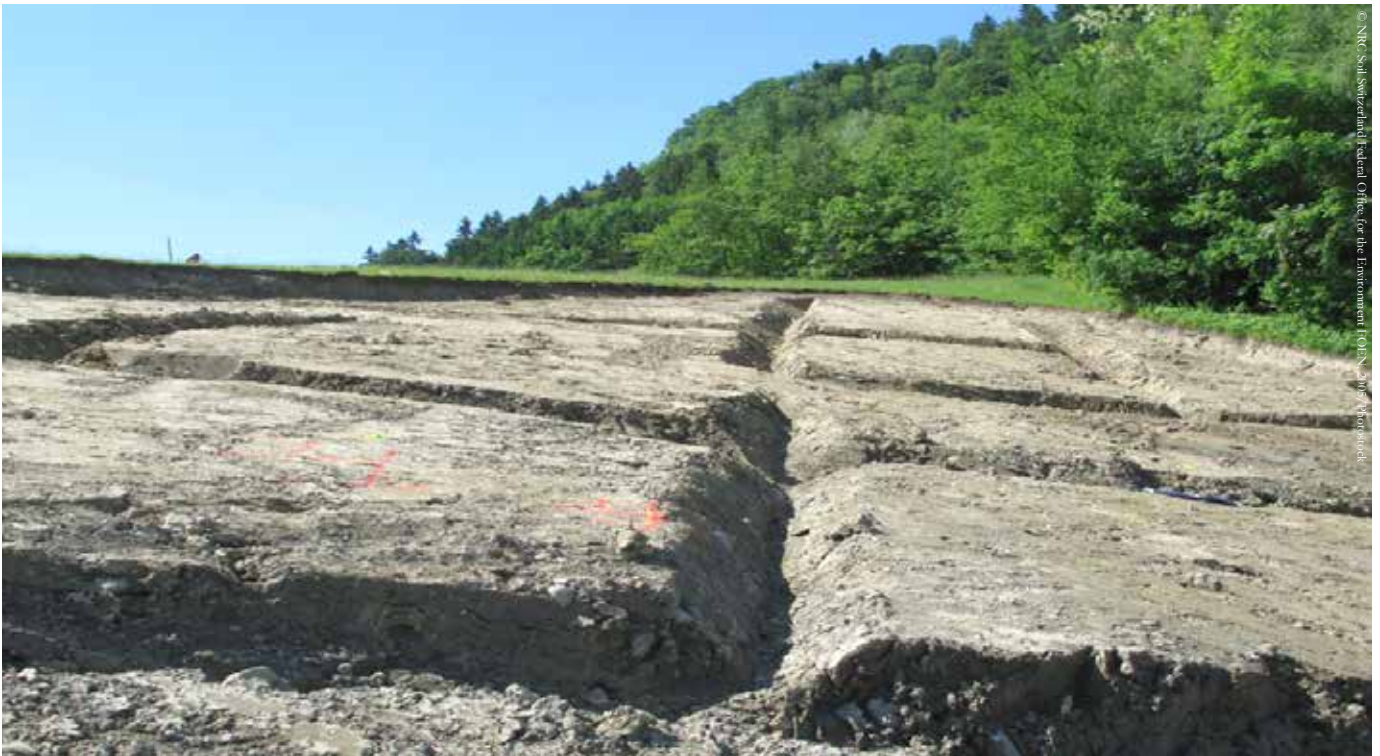
Construction of surface drainage features for controlled management of the rainwater

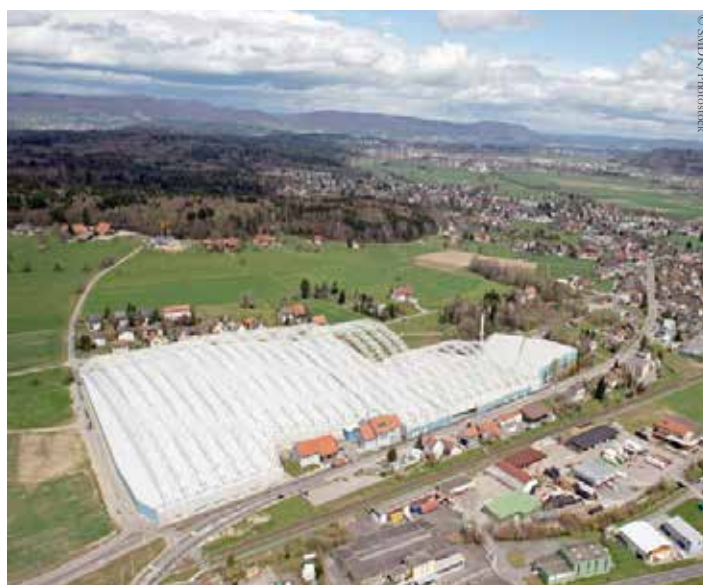
The site of the Kölliken hazardous waste landfill showing complete enclosure for the remediation works (2007- 2018)

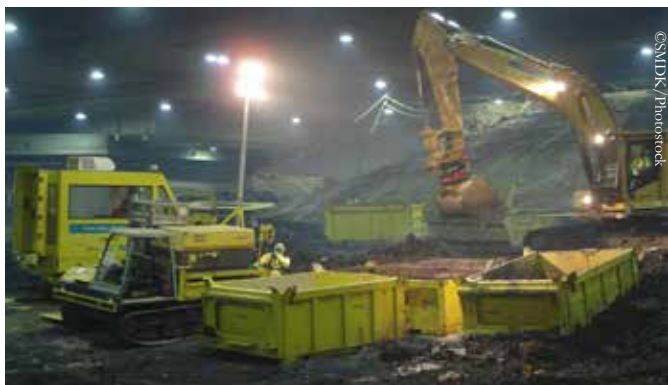
Typical configuration of the landfill dismantling activities during the first dismantling stage (2007-2009).

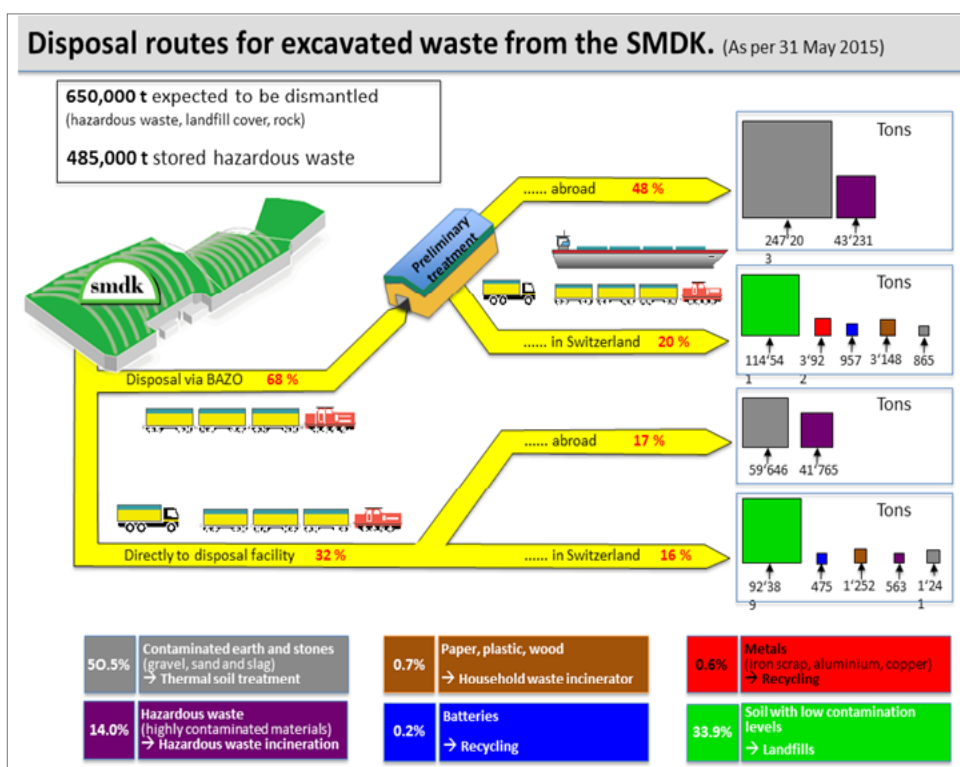
Disposal routes for excavated waste from the SMDK. As per 31 May 2015.

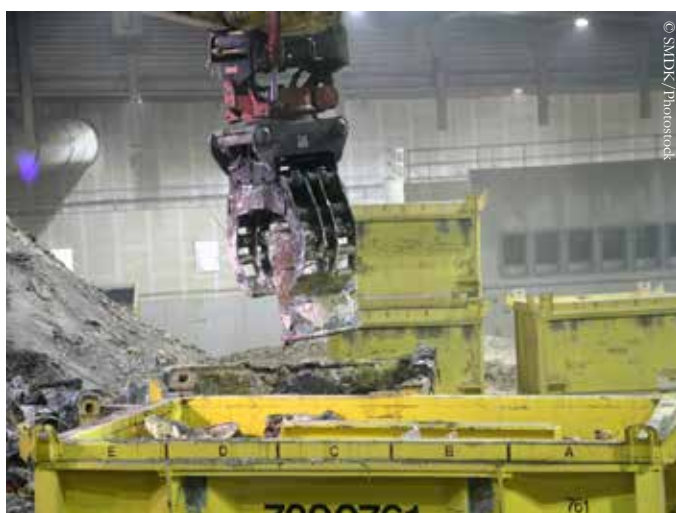
Retrieving a waste drum with the excavator.

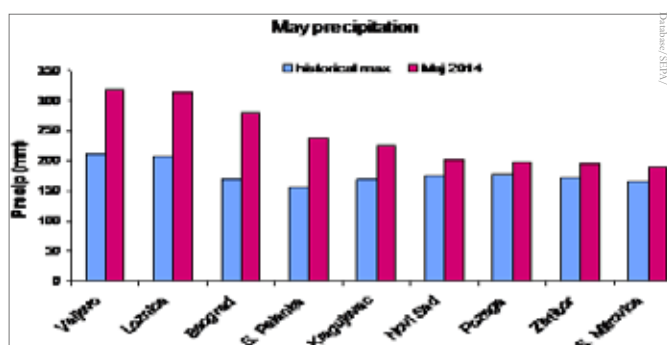
May 2014 precipitation in Serbia compared to historical maximum

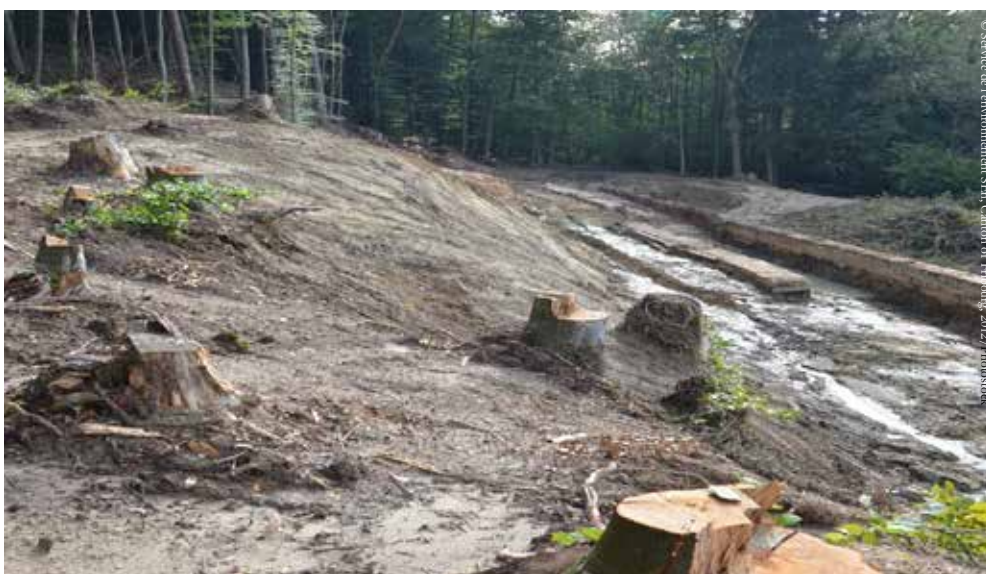
Former indicator and indicator trench with decontaminated earthen backstop.

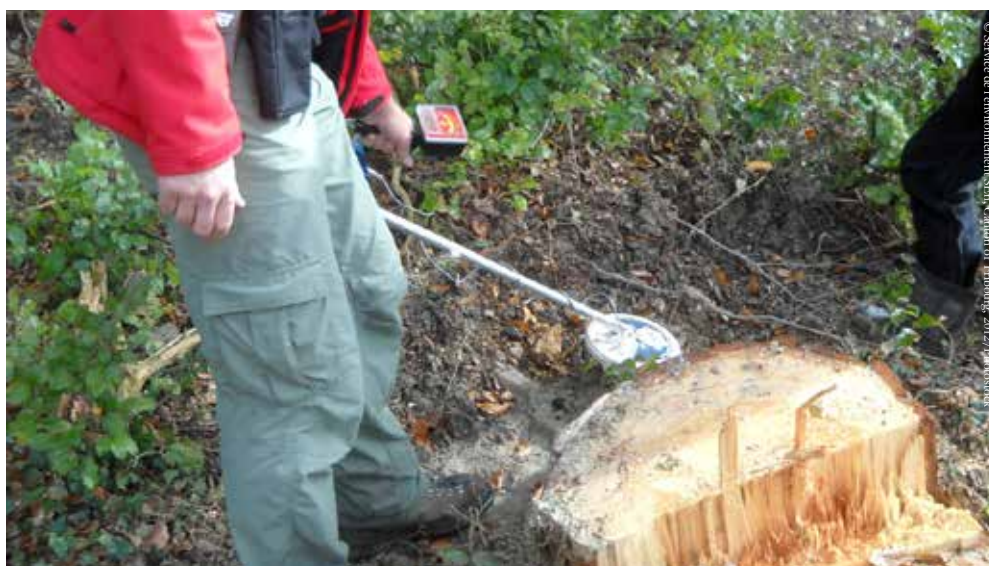
Individual small hotspots are identified with the metal searching device.
